**BLACKSTONE RIVER BASIN
WORCESTER, MASSACHUSETTS**

**QUINSIGAMOND POND DAM
MA 00139**

**PHASE I INSPECTION REPORT
NATIONAL DAM INSPECTION PROGRAM**

AUGUST 1978

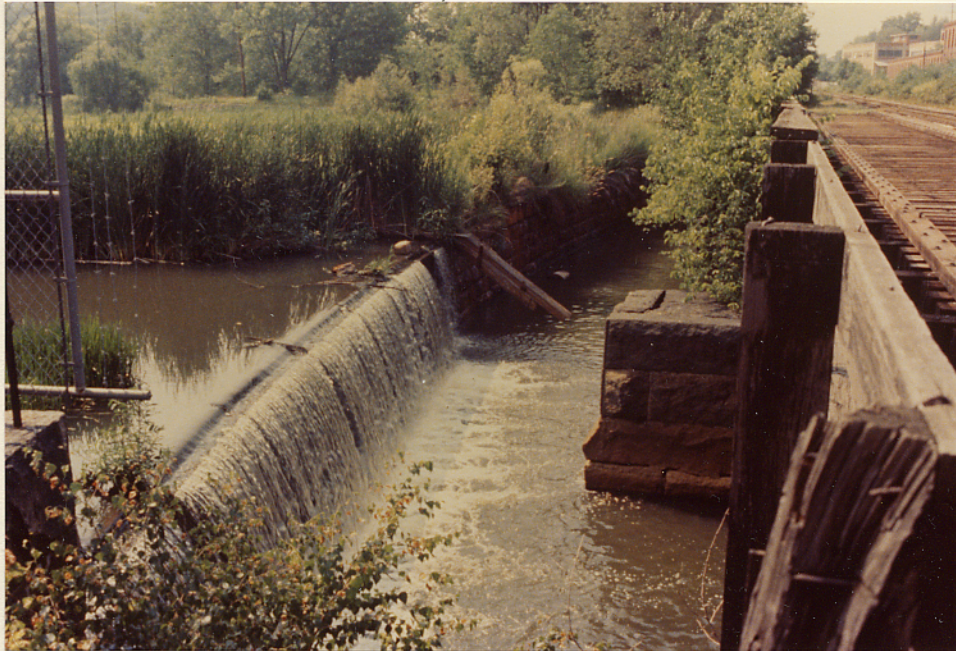
**OVERVIEW
QUINSIGAMOND POND
WORCESTER, MASSACHUSETTS**

VIEW FROM SOUTH ABUTMENT

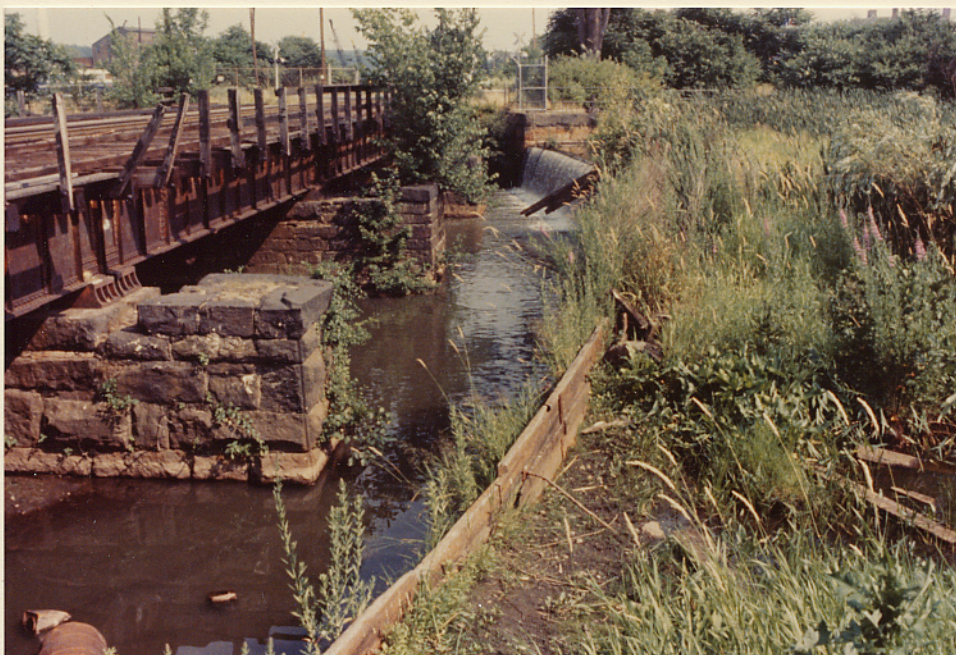
**NO. 1 VIEW OF DAM CREST AND RAILROAD
BRIDGE FROM NORTH ABUTMENT**

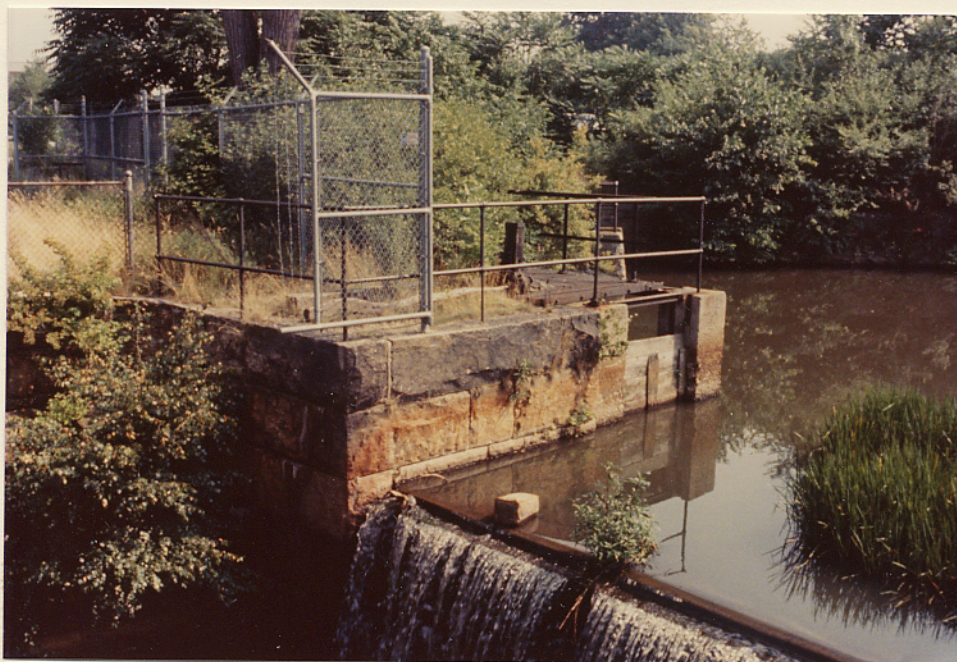
Two outlets which are located at the south abutment of the dam are surrounded by a locked chain-link fence. The channel nearest the spillway is in poor condition. The approach channel and intake are submerged, and the stone masonry sidewalls and concrete headwall of the outlet structure appear to be in fair condition. The wooden parts of the gate stem are missing, however, making the gate inoperable. There is a thick growth of shrubbery on top of the outlet structure. The outlet channel which connects with the spillway channel appears to be clear of debris.

**NO. 2 VIEW OF SOUTH ABUTMENT
SHOWING ABANDONED INTAKE STRUCTURE**

- (3) repair the gate stem on the outlet works next to the south abutment of the spillway and determine that the gate operates properly
 - (4) clear trees and brush from the earth embankment at the south end of the dam near the outlet structures

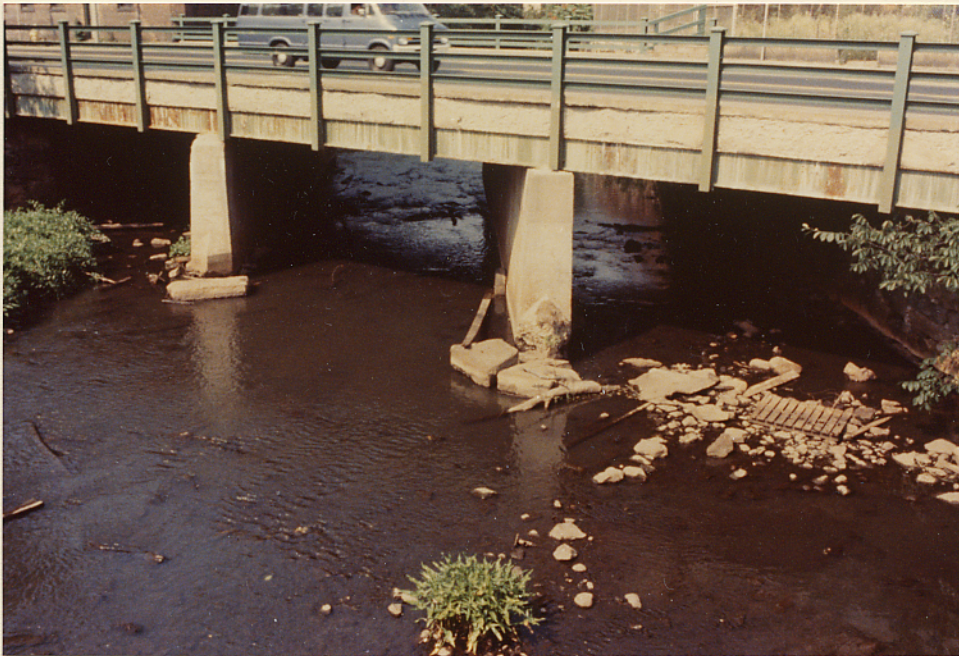
**NO. 3 VIEW OF GREENWOOD STREET BRIDGE
DOWNSTREAM FROM DAM**

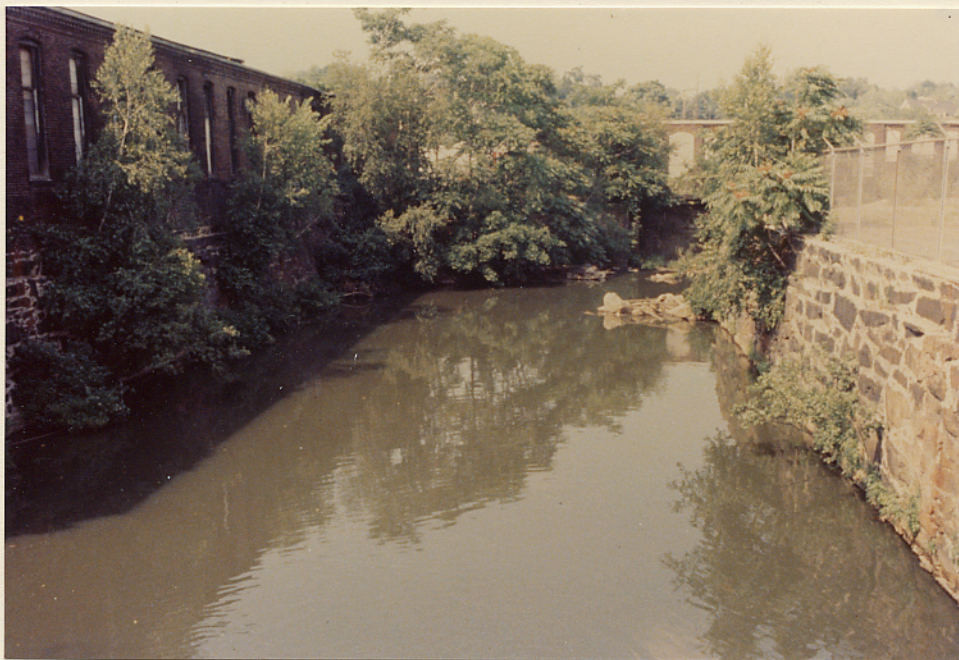
**NO. 4 VIEW OF DOWNSTREAM CHANNEL FROM
GREENWOOD STREET BRIDGE**
